LONG PINE RUN DAM

PHASE I INSPECTION REPORT

NATIONAL DAM INSPECTION PROGRAM

National Dam Safety Program. Long Pine Run Dam (Inventory Number NDS-328), Birch Run, Potomac River Basin, Adams County, Commonwealth of Pennsylvania. Phase I Inspection Report.

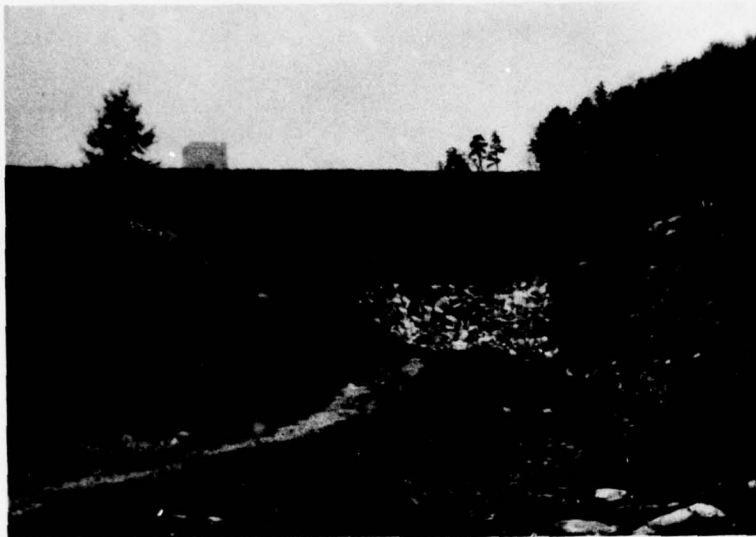
The dam embankments are in good condition. A large area of the downstream slope has been seeded with vetch. The berm at elevation 1300.0 has some wet areas caused by poor drainage. The concrete gutter at the right embankment needs some cleaning, especially the gutter on the berm. This will reduce the amount of water running onto the berm. Bike riders caused some scars on the embankment slope. These areas and a few erosion spots on the slope need repair and reseeded.

General View of
Downstream
Embankment

1. Owner should employ an experienced engineer to investigate the erosion in the spillway chute and contract for necessary repairs if deemed necessary to prevent undermining of the retaining wall.
2. Owner should maintain embankment slopes by repairing eroded areas and seed ground cover.

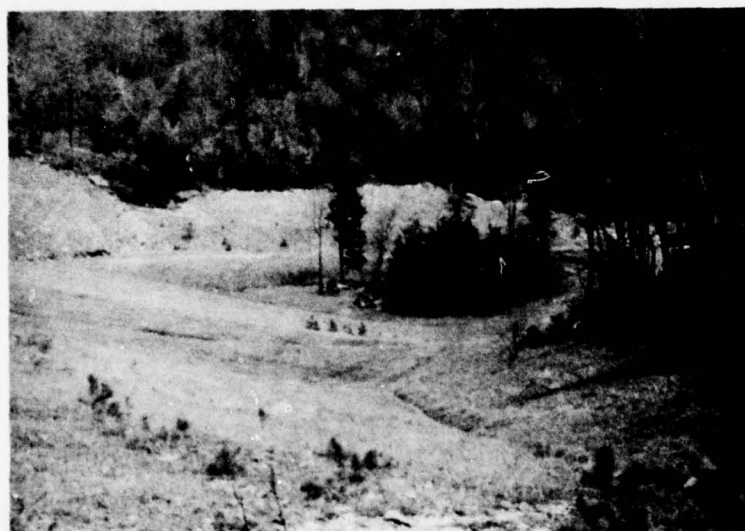
Right
Embankment
Abutment

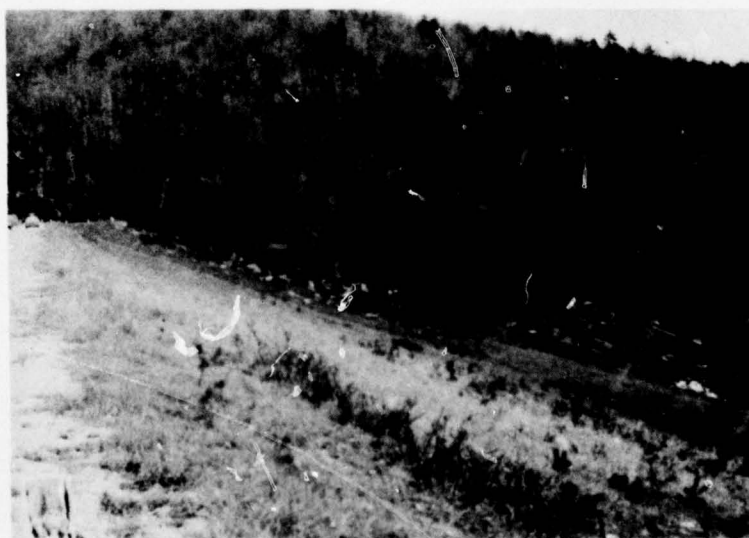
Top of Dam

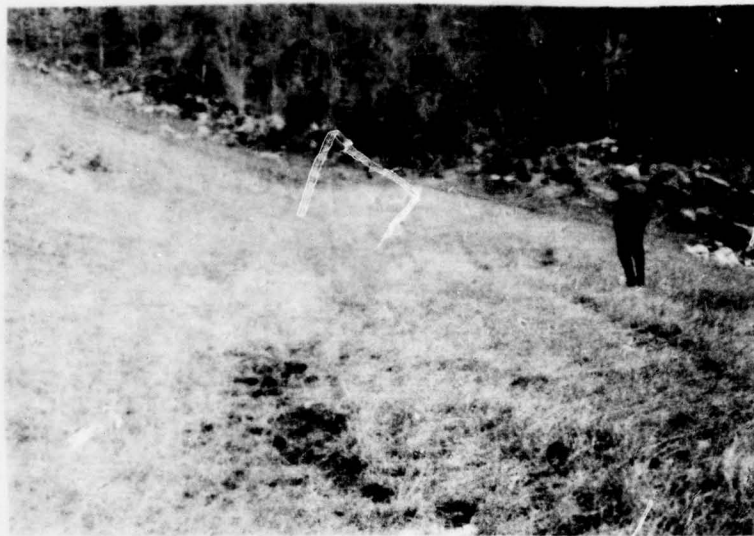
Design criteria for embankment stability was not available in the files. The indicated zoning and slopes of the embankment appear to be adequate for this type of construction. The grouting take was limited and this indicates a good foundation. The borings indicate a good subsurface and the dam appears to be well engineered. No seepage problems have occurred. The cross slope and longitudinal profile of the berm prevents good drainage and water was standing on the berm.

Berm With
Wet Area

Eroded ditch on lower slopes
from terrace or berm. Should be
repaired with possible regrading
of entire terrace. Other erosion
and rutting on lower slope at random
mostly on left side upstream.

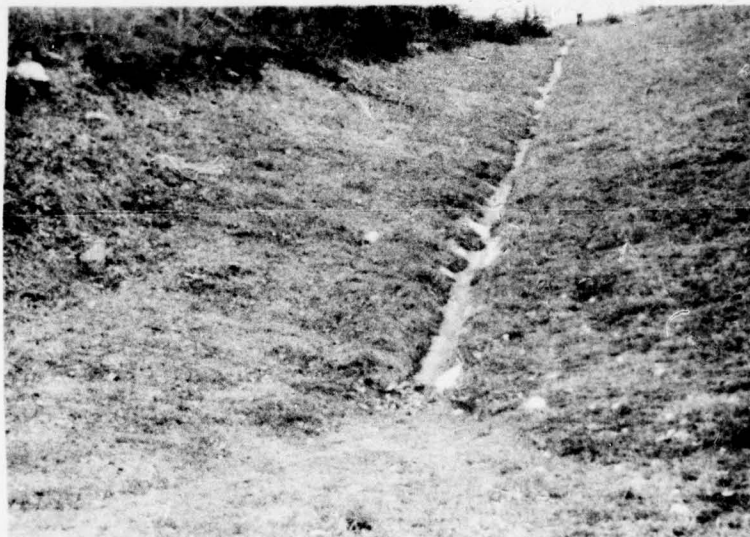
D. VERTICAL & HORIZONTAL ALIGNMENT OF CREST	No distress stoned roadway on breast	
E. RIPRAP FAILURES	No evidence	
F. JUNCTION EMBANKMENT & ABUTMENT OR SPILLWAY	Appears sound - no distress Some rutting due to roadway extension up over slopes to top of dam	Concrete gutter on right abutment should be cleaned

Right Concrete
Gutter

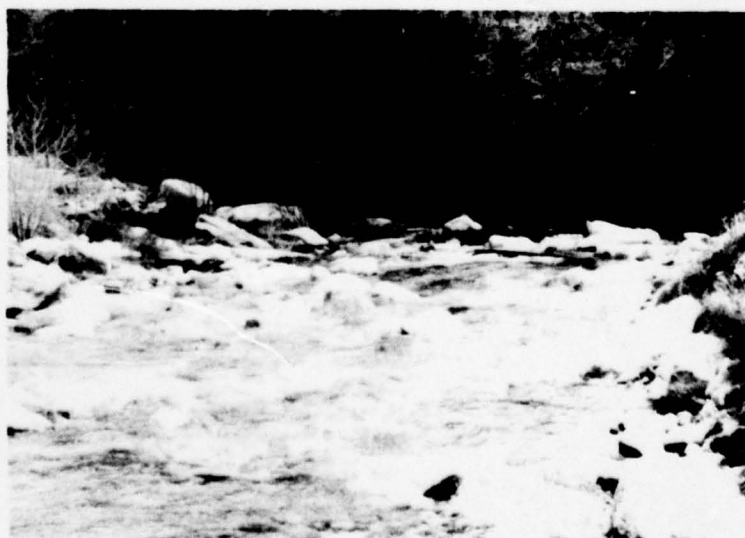
The downstream channel appears to be clean and clear of obstructions. The ford built across it has been damaged and is not usable.

Downstream
Channel

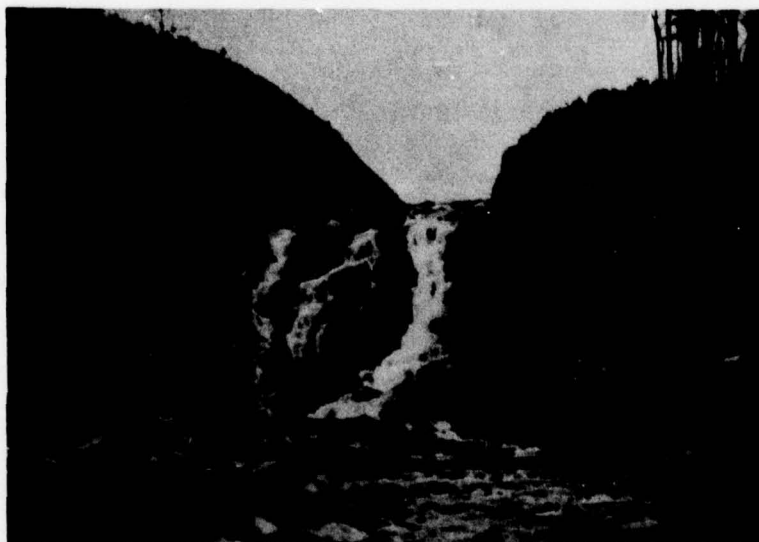
Spillway and
Stilling Basin
